Photo audit of Railway Road link Asda to Abercorn Square

<p>Abercorn Square to Asda, North side</p> <p>Looking toward Abercorn Sq. the theatre steps make an interesting feature. The walking environment is good.</p>

Asda to Abercorn Sq., south side

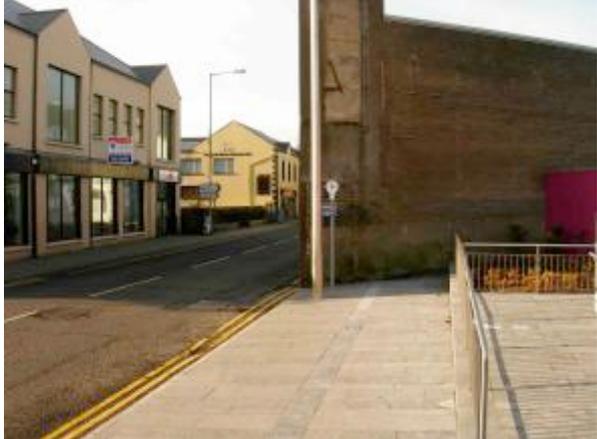
<p>Immediately past the theatre, heading towards Asda the footway abruptly ends.</p>

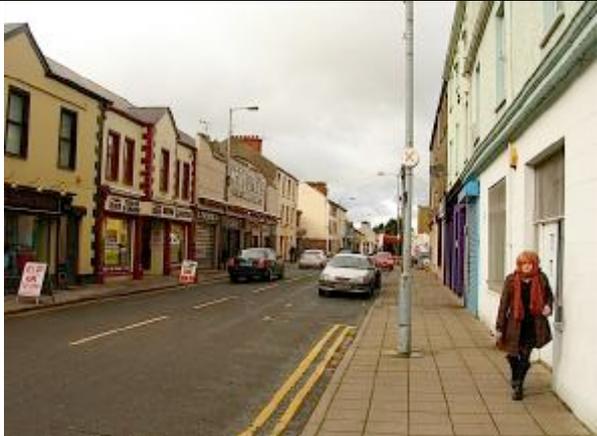
<p>After Dock Street the footway begins again. It is of reasonable width, but this is reduced by the lamp posts that are located twice the required distance from the kerb.</p>

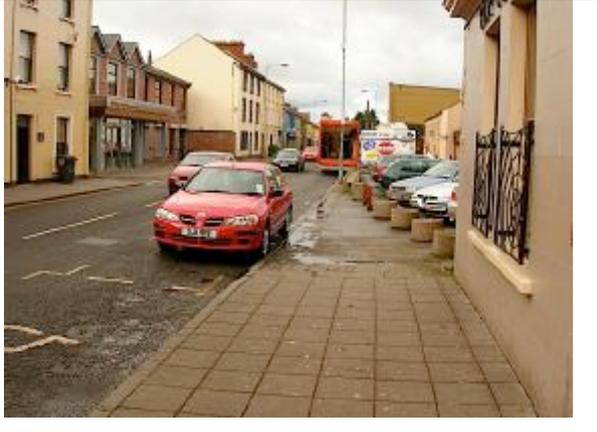
<p>Shorty after, the footway again ends, as a parking forecourt encroached up to the kerb line.</p> <p>Note that there would be space to create a new footway in advance of the kerb line, occupying space that is currently taken up by parked vehicles.</p> <p>There are ambiguous markings here with a partially painted single yellow line within a parking bay.</p>

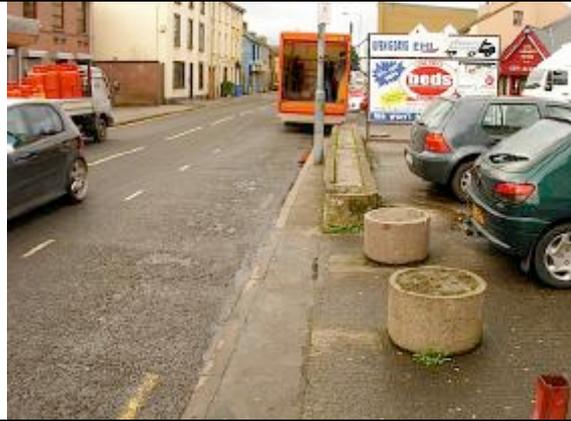
This photo illustrates that there is sufficient width to accommodate two-way vehicle traffic without encroaching on the parking bay. The parking bay should be removed and converted to footway (unless the private forecourt land can be converted to footway).

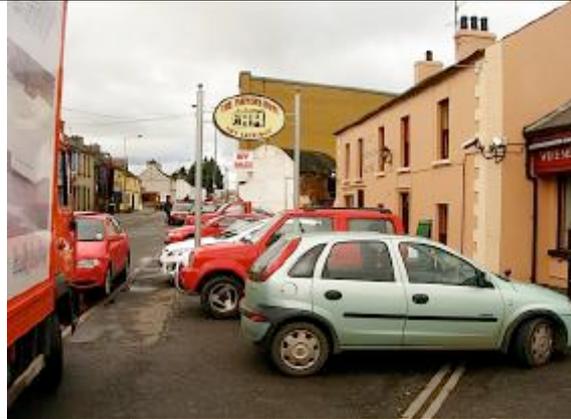
Immediately beyond the previous location, a pub forecourt is taken up entirely by parked cars, while a service vehicle is parked with two wheels on what remains of the narrow footway. Again, people cannot walk here except in the carriageway.

The parking also destroys the appearance and convenient entry to the pub.

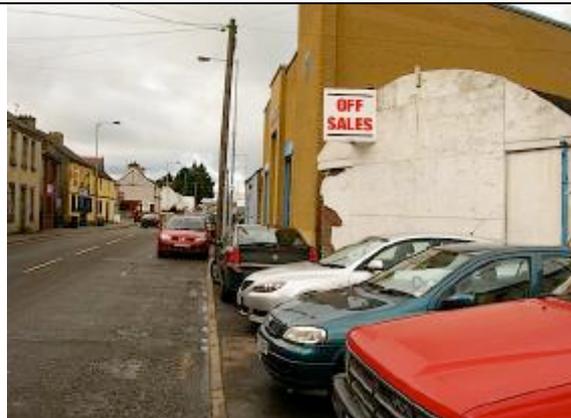
Parking on the footway is clearly regarded as acceptable. This behaviour is encouraged by the fact that the footway on this road is discontinuous.

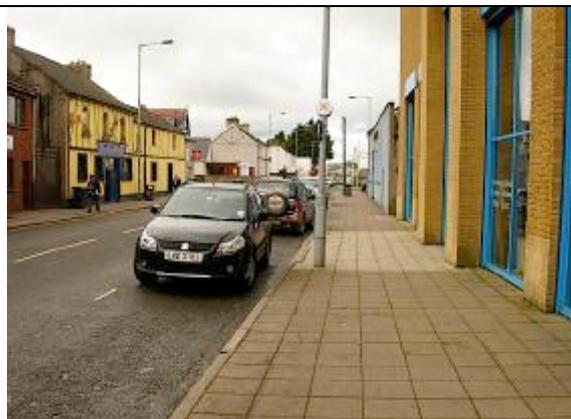
Once alongside a recent development, the footway is of a good standard and width.

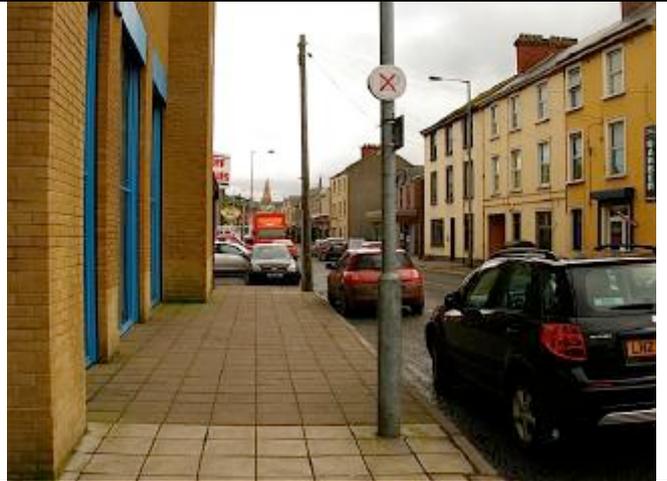
Looking back towards the forecourt. parking obstruction. This is what would confront anyone walking from Asda towards the town centre.

It cannot be said that there would be no demand for secondary journeys to the town centre on foot, when these journeys are so poorly provided for.

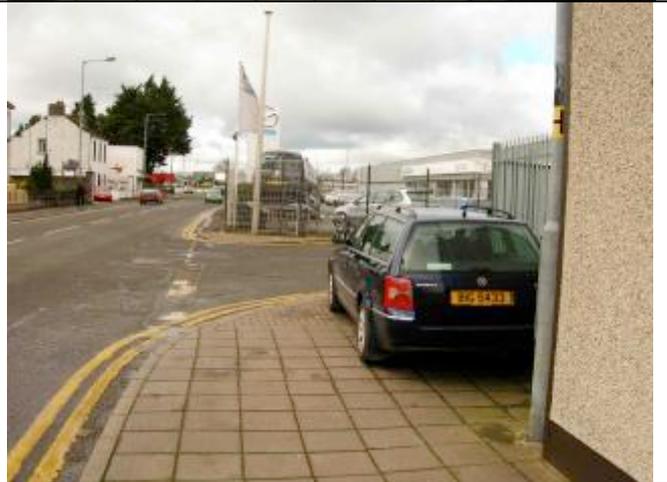
Footway parking approaching the Mazda forecourt. The junction with Park Road is dangerous for pedestrians

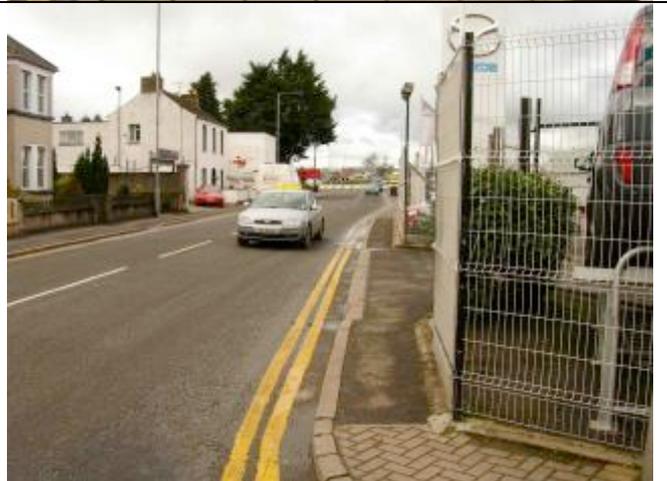
The Mazda forecourt encroaches onto the footway.

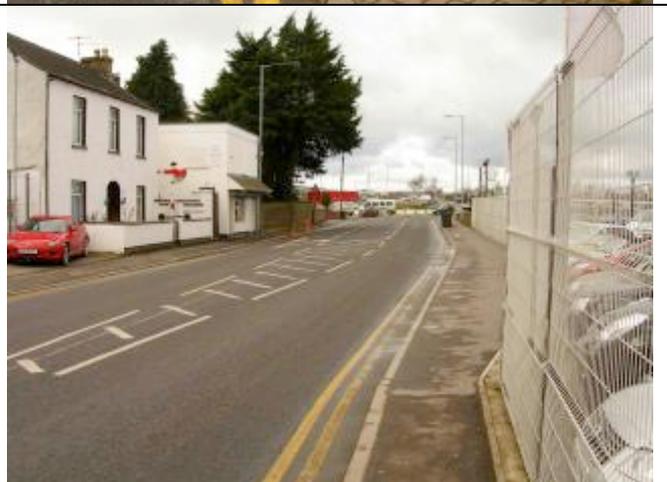
Priority is given to people in vehicles. Footway width is sacrificed for the creation of a hatched area and right turn lane for the Mazda entrance.

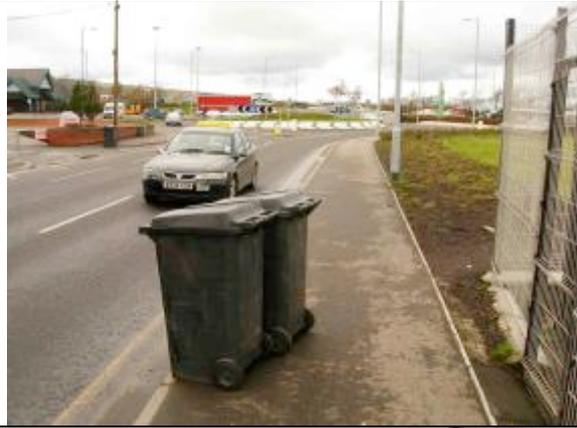
The approach to Asda roundabout

Evidence of people taking a short cut across the grass to Asda. This arises because the Asda entrance is at the back of the car park instead of at the street frontage.

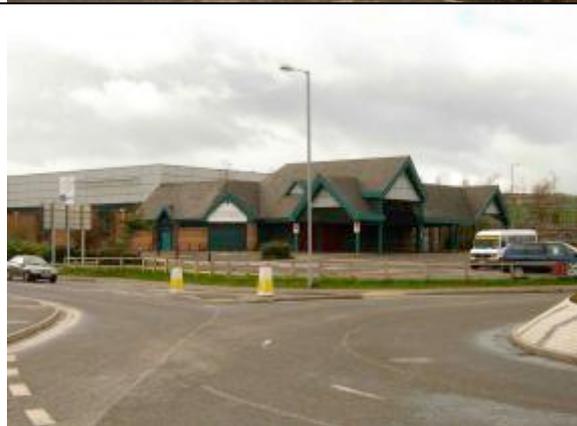
The roundabout between the two Asda sites is provided with dropped kerbs, but the speed of drivers means that it can be difficult to cross.

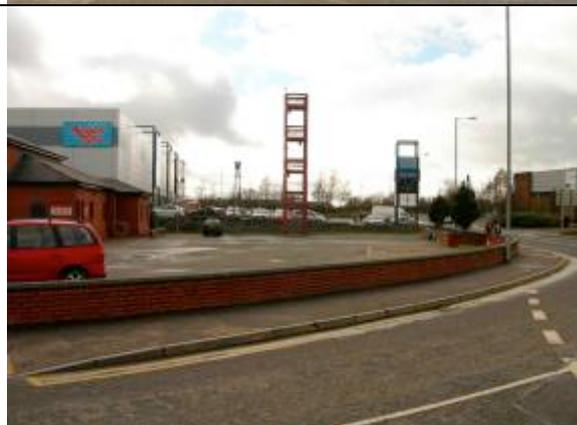
People visiting both Asda and the other retail units may choose to drive between the two sites. The walking environment here is unpleasant and traffic-dominated.

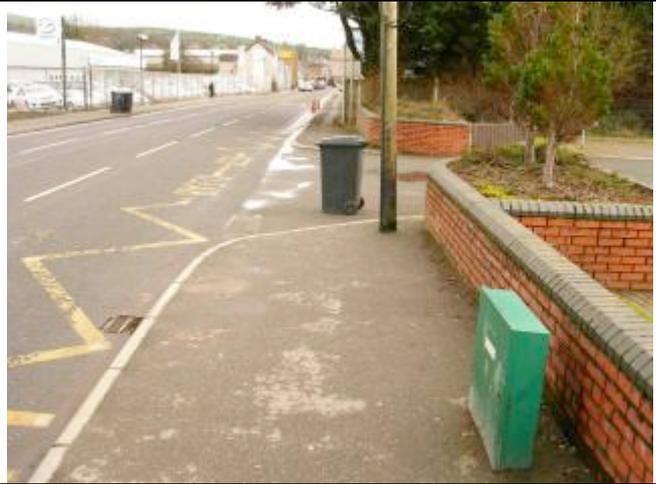
The vehicle entrance gives vehicles priority over pedestrians.

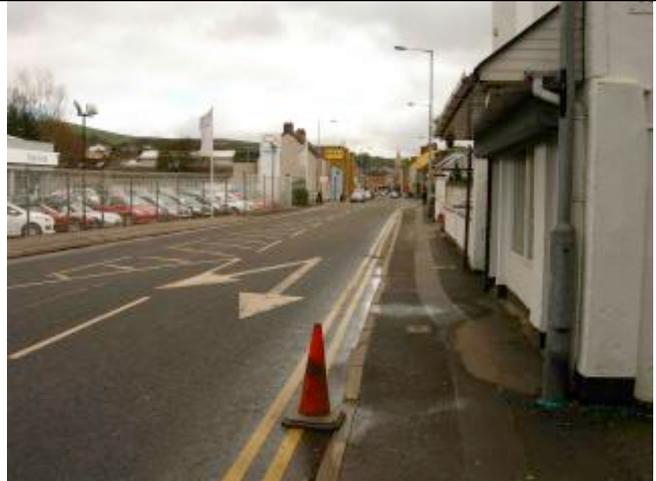
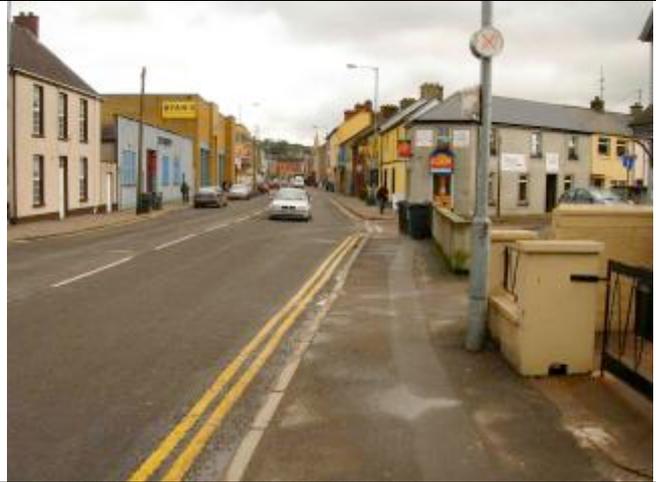
Railway Road is marked out as highway, which dominates its character. The building frontage is reasonable. The lamp post is set to the back of the footway, which maximises pedestrian space.

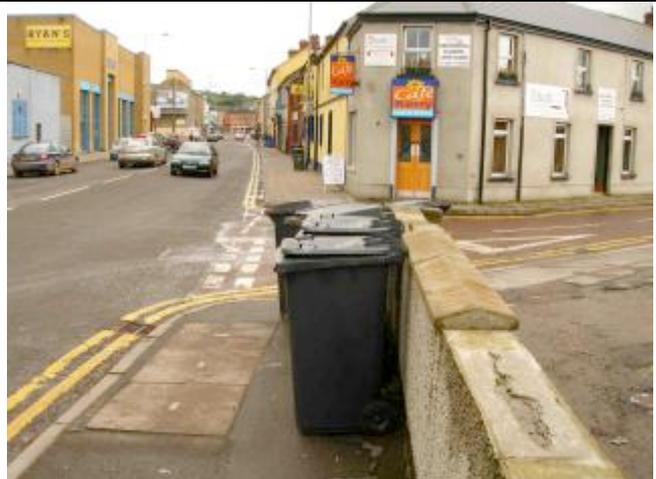
The footway is treated as a dumping ground for wheelie bins, reducing the width of the footway.

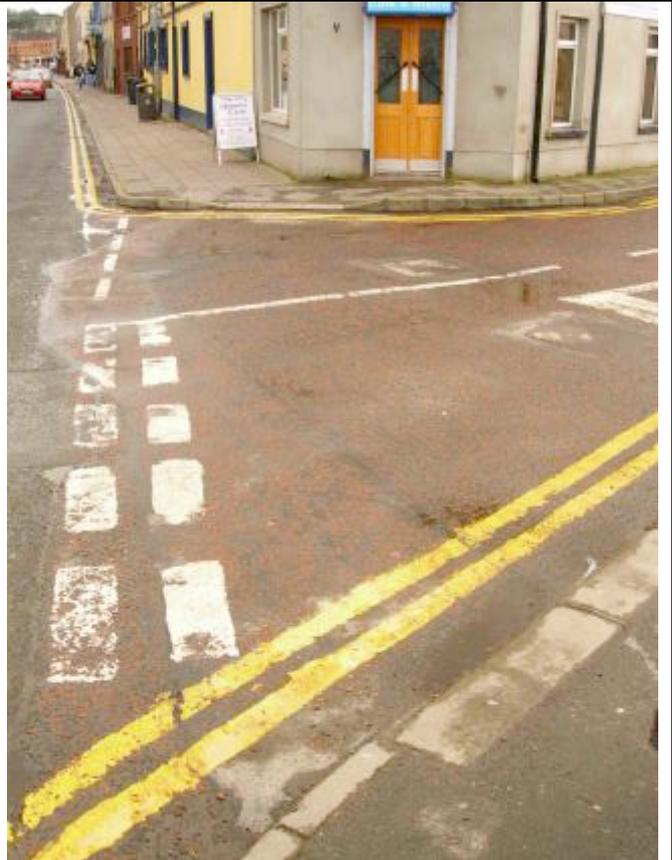
Junction with Eden Terrace is not pedestrian-friendly, and materials and markings are unsightly.

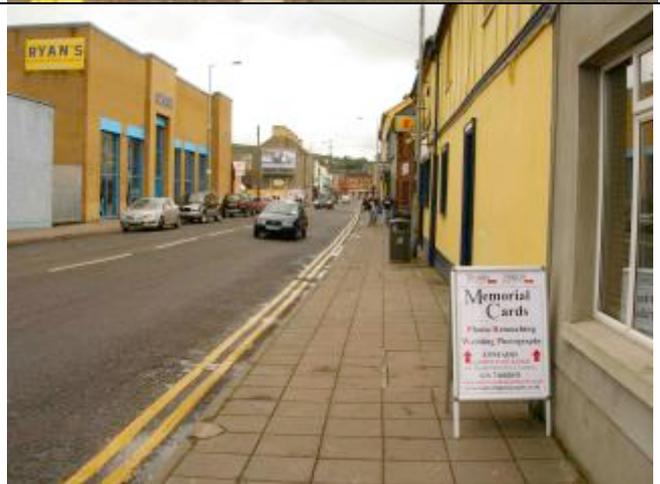
The ample width for vehicles is illustrated

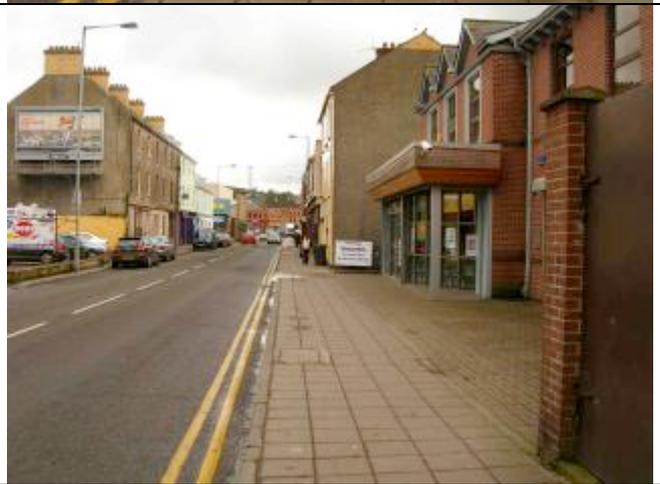
The footway widens, creating some "breathing space" but this also interrupts the building line, and has led to the exposure of an unsightly gable end.

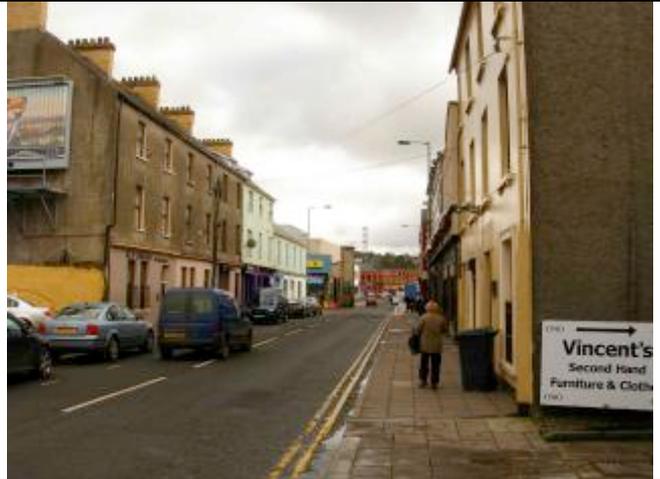
The blank return wall is pressed into service for a commercial sign.

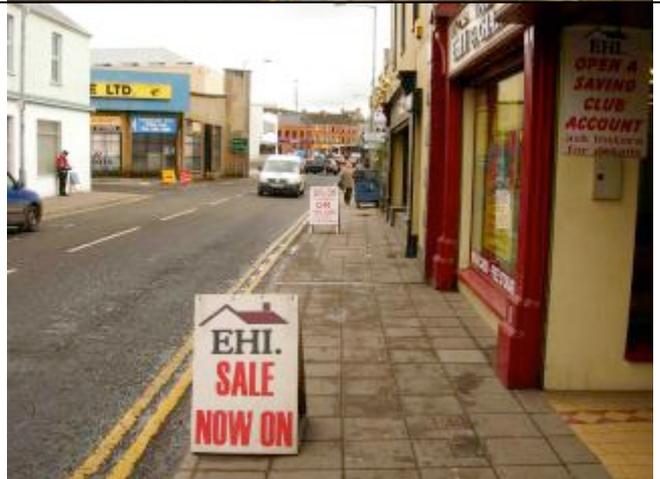
"A" boards narrow the footway and can be unsightly. Together with the large refuse bin the footway all but disappears.

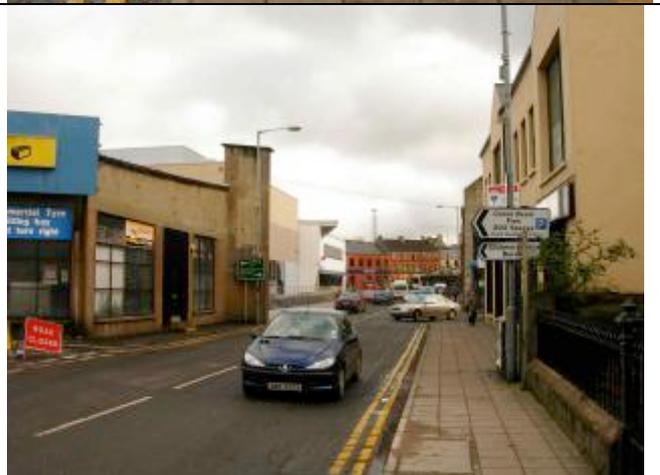
The wall obstruction on the north side is clearly seen. On the south side the footway is reasonable up to John Wesley Street.

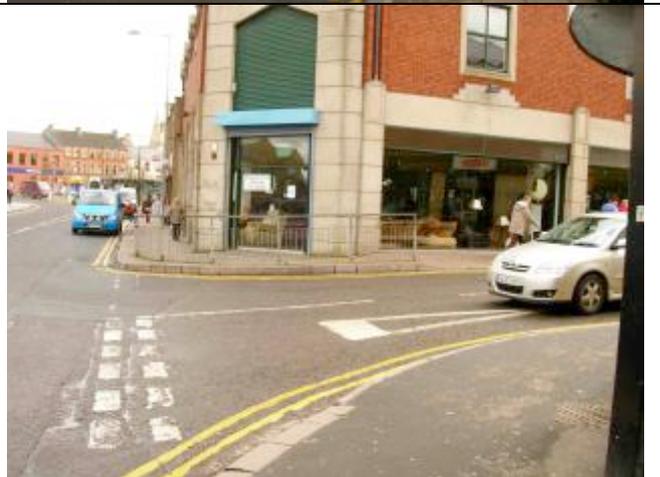
The junction with John Wesley Street is inconvenient for pedestrians, who are forced round the corner by guardrailings to the point where their visibility of turning vehicles is obstructed.
